Geotechnical Site Evaluation

87052 Vesta Lane

September 29, 2021

CGS Project No. 21096

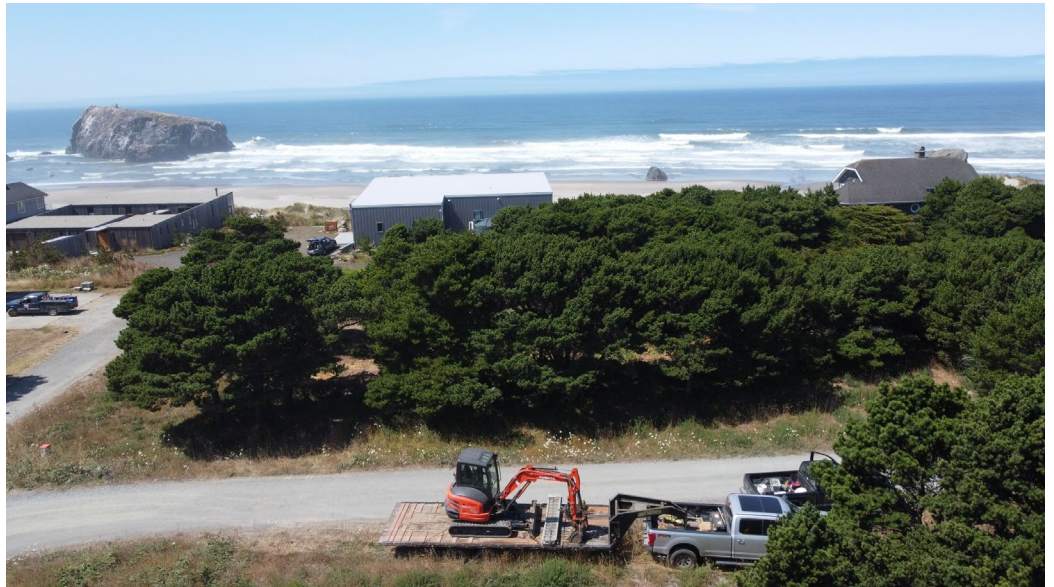
Aerial view of the site looking west

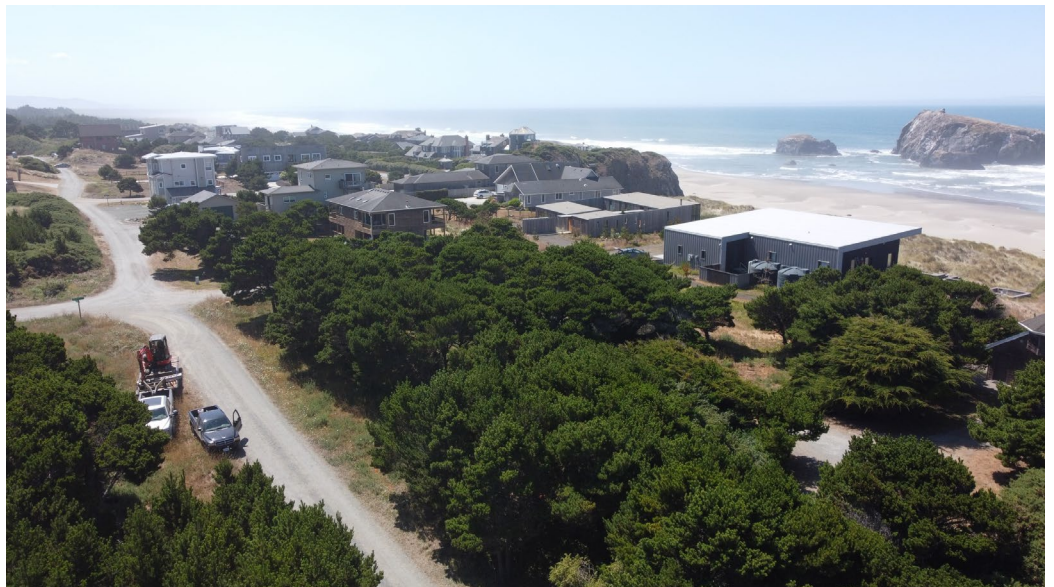
Photo No: 2

Aerial view of the site looking south

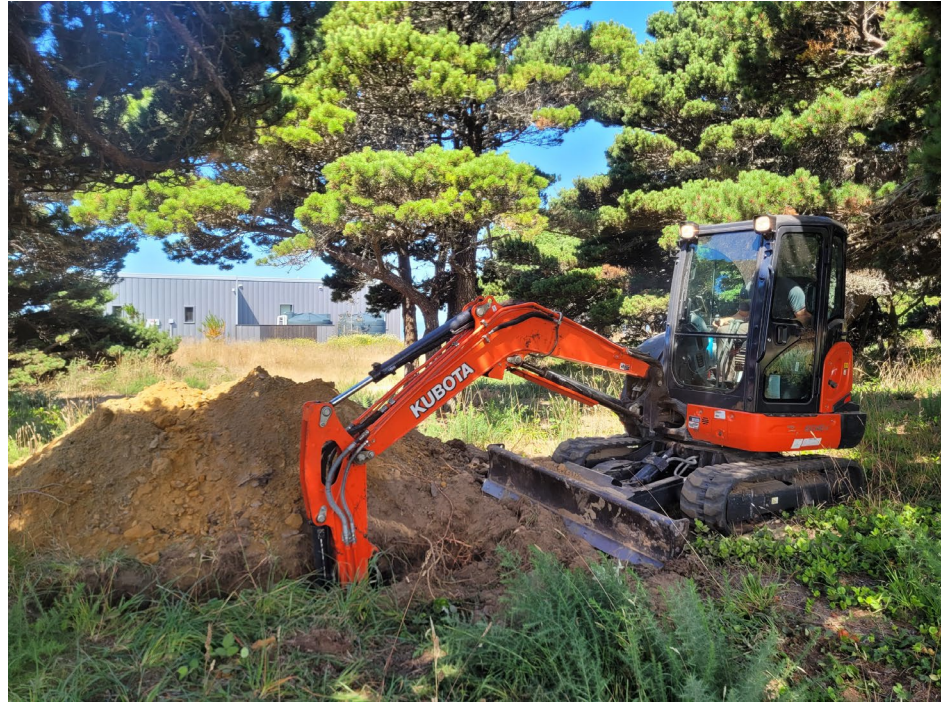
CGS observed the excavation of five test pits on the site.

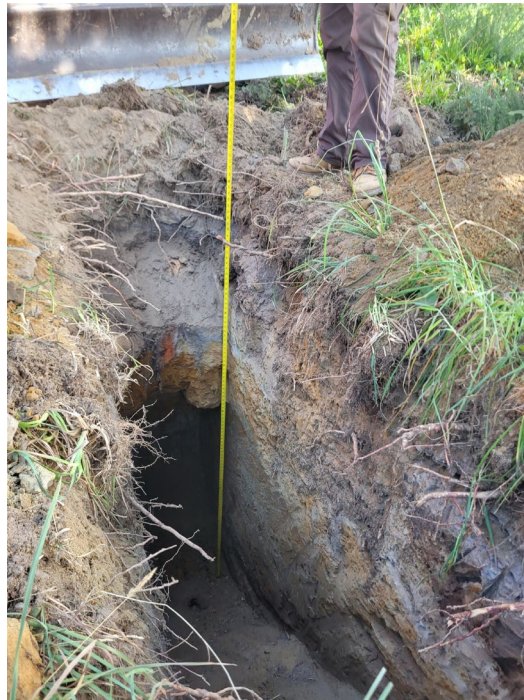
Photo No: 4

Our test pits encountered loose sandy organic topsoil which overlays medium dense tan-brown fine sand (Photo 4). The sand is well cemented and is part of the surficial Quaternary Marine Terrace Deposits as identified by others². In test pits TP-2 and TP-3 which were excavated in the northeastern portion of the site, a very dense dark gray gravel was encountered near surface (Photo 5). The gravel was very difficult to excavate causing TP-2 to be abandoned at 0.5 feet bgs and TP-3 to be started. TP-3 also encountered the gravel at 1.0-foot bgs which caused abandonment at 5.0 feet bgs. A review of historical photographs of the area⁴ indicate that a north-south road existed on this portion of the site that was subsequently abandoned and replaced by Roher Road to the east. We infer that the gravels encountered in TP-2 and 3 are part of the older roadbed.

Topsoil encountered from 0.0 to 1.0 feet over lays medium-dense, tannish brown and reddish brown, silty fine sand.

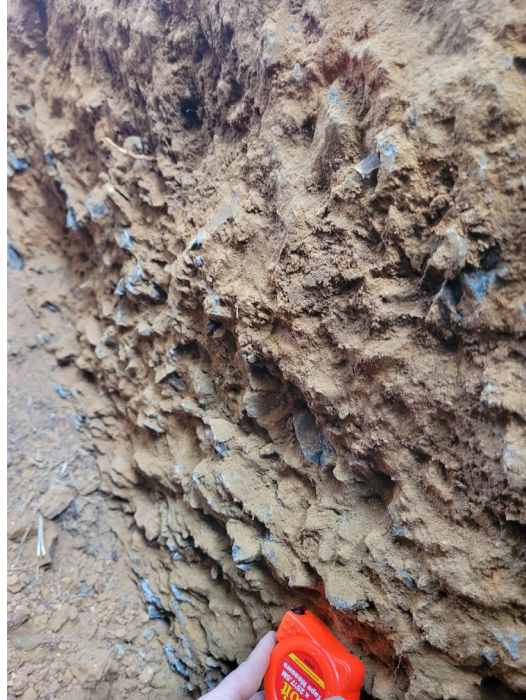
Gravel: Encountered from 0.0 to 0.5 feet bgs in TP-2 and from 2.0 to 5.0 feet bgs in TP-3. Consists of dark greenish gray volcanics (see Photo 5). Where it was encountered near the surface in TP-2, it was observed to be very dense, causing abandonment of the test pit.

Bedrock was encountered near the surface in TP-2 and was medium weak (R3) dark greenish gray severely weathered and highly fractured volcanics.
