STATE OF OREGON
DEPARTMENT OF TRANSPORTATION
PLANS FOR PROPOSED PROJECT
GRADING, DRAINAGE, STRUCTURES, & PAVING
SANDY CREEK RD AT MILE POINT 2.70
COUNTY ROAD 89
COOS COUNTY
MAY 2024

SANDY CREEK – EMERGENCY RELIEF PROJECT MP 2.70

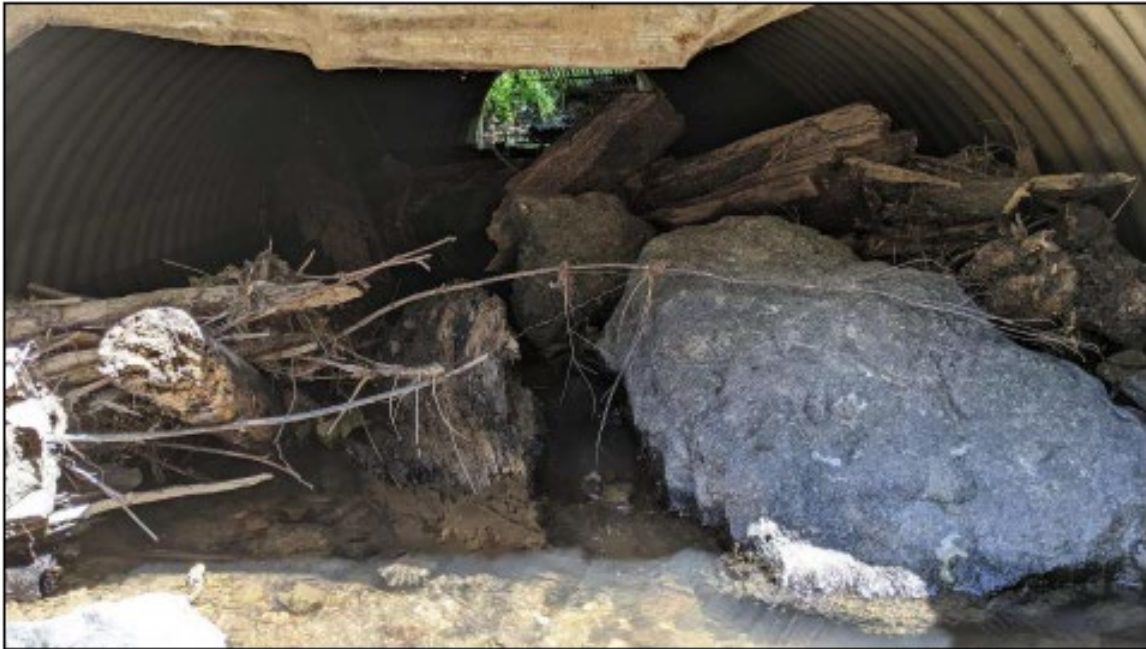
The Unnamed Tributary (UNT) is a tributary of Sandy Creek, which flows into the Middle Fork Coquille River. During a flood event in 2018, the existing culvert was overtopped, damaging Sandy Creek Road. An emergency repair that lowered the roadway and placed large riprap along the downstream side of the road failed in January 2021. The culvert collapsed and riprap fell into the stream at the downstream end of the culvert, blocking flow (see Attachment B Photographs).

Photo 7: View looking upstream from the downstream side of the partially blocked culvert.

The existing damaged 5-foot diameter CMP culvert will be replaced with a 32-foot long and 28-foot-wide single span concrete slab bridge, supported on a geosynthetic reinforced abutment (GRS). The road and bridge will be elevated approximately 4 feet above existing grade. Vertical clearance between the Ordinary High Water elevation and the low chord of the bridge will be 10 feet. Creating the clearance under the bridge, along with the depth of the slabs, will require the road elevation to be raised at the bridge and tapered back to the existing road grade for more than 120 feet on each side of the bridge. The bridge approach and guardrail will require a wider roadway on each side of the bridge, extending approximately 24 feet on each side of the bridge center. The bridge will span more than 2.5 times the active channel width. Design plans are provided in Attachment C.

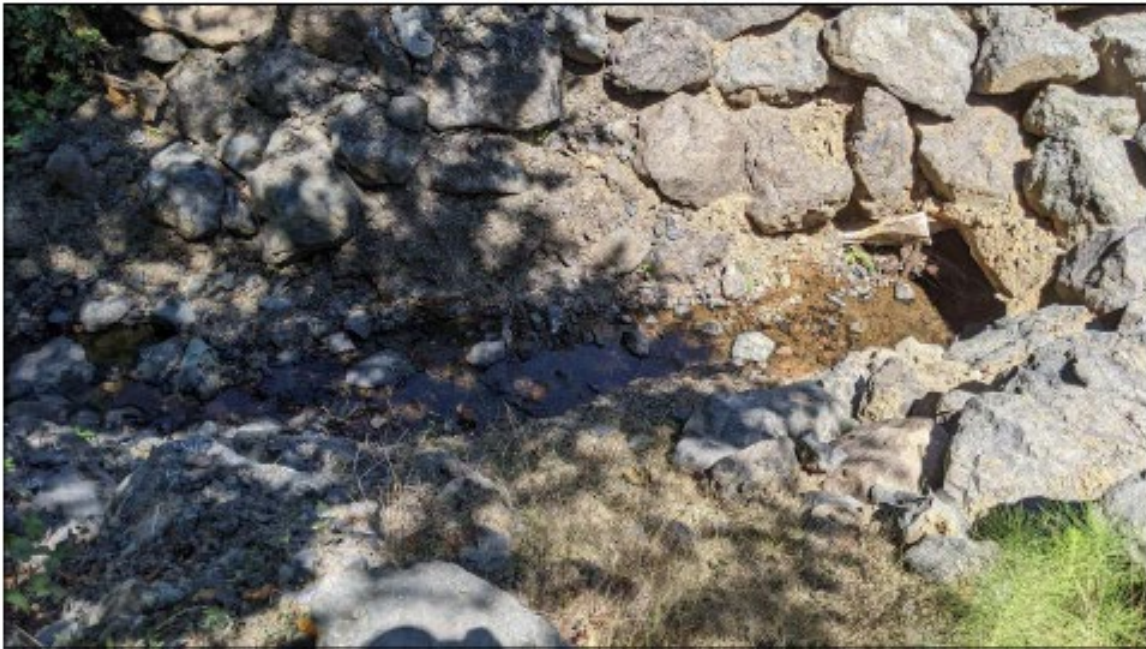
Photo 8: Stream conditions immediately downstream of the culvert. Large rock was used to stabilize roadway after culvert collapsed.
